# Test Report

Report No. A224053840410100102

Sample Name PET-G membran  
Sample Received Date Sep. 2, 2024  
Testing Period Sep. 2, 2024-Sep. 12, 2024

Test Item: Alternating test

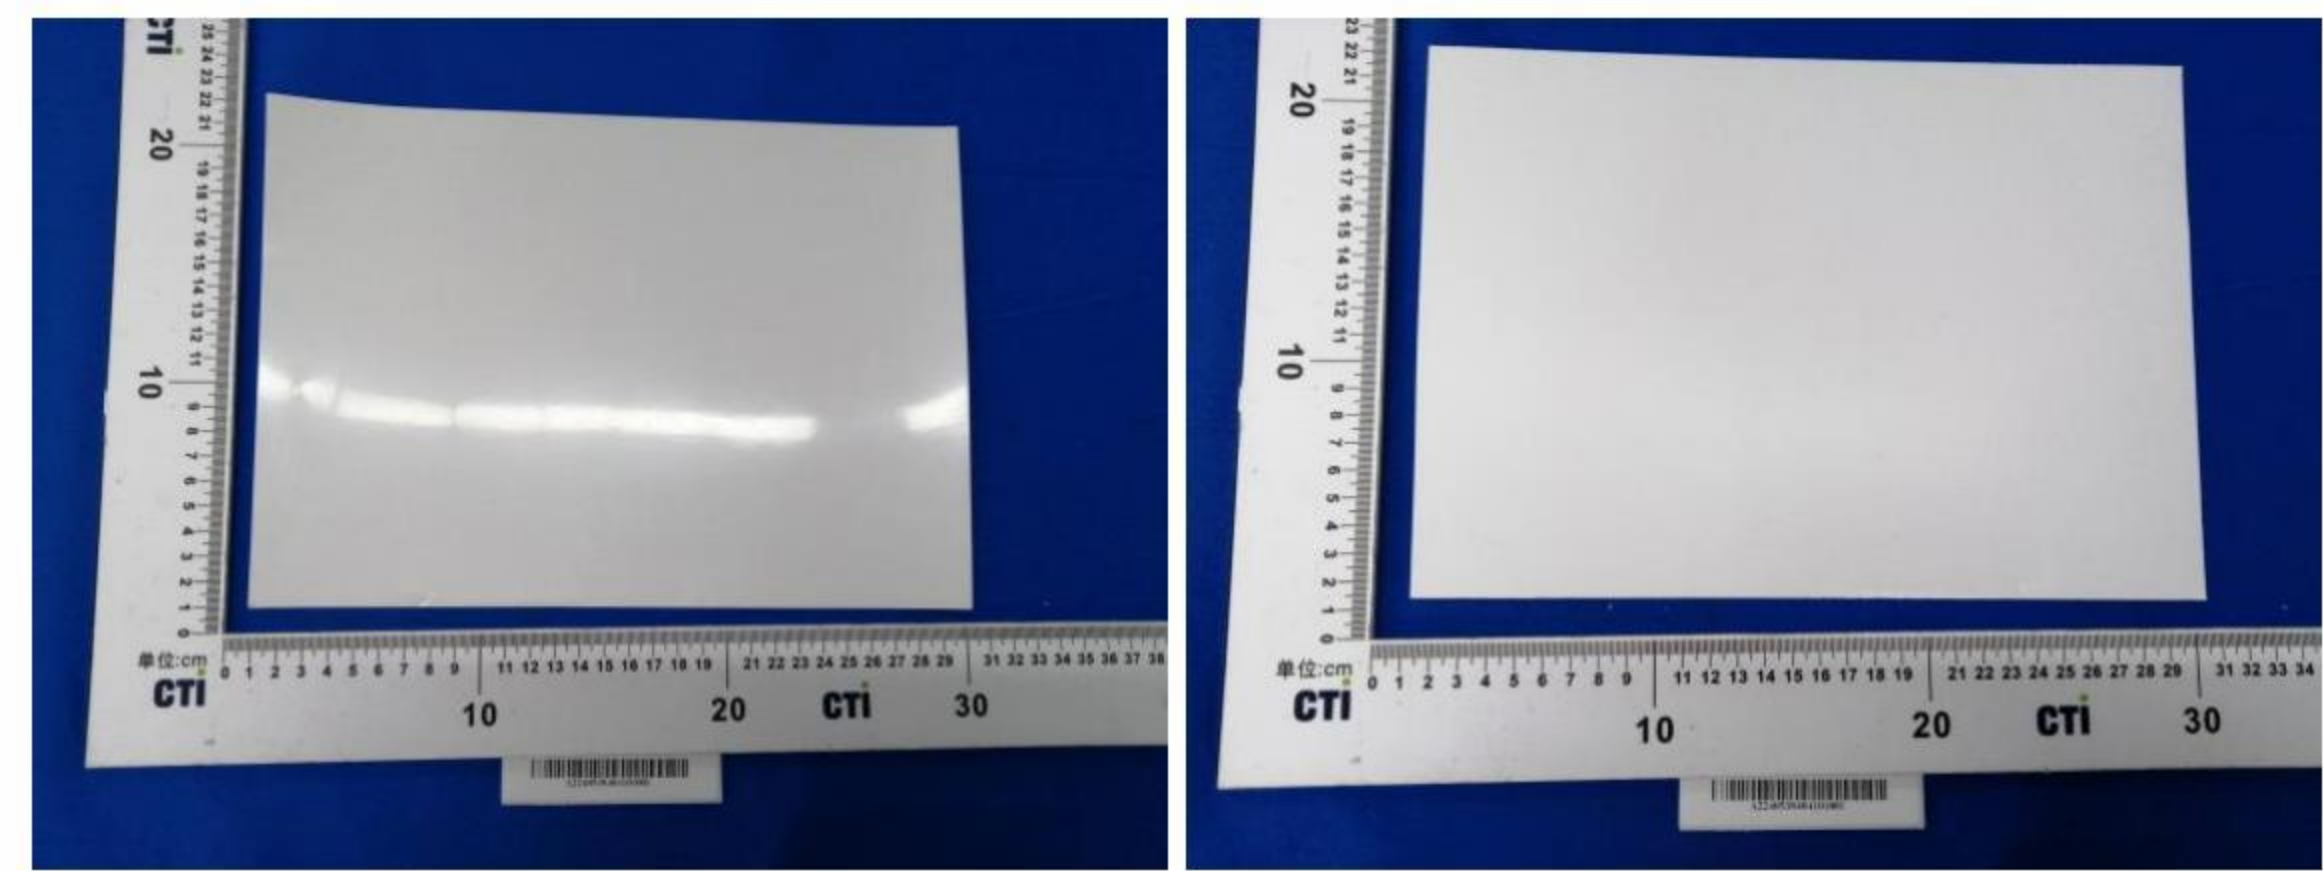
A2240538404101001

Sample Photo(s)

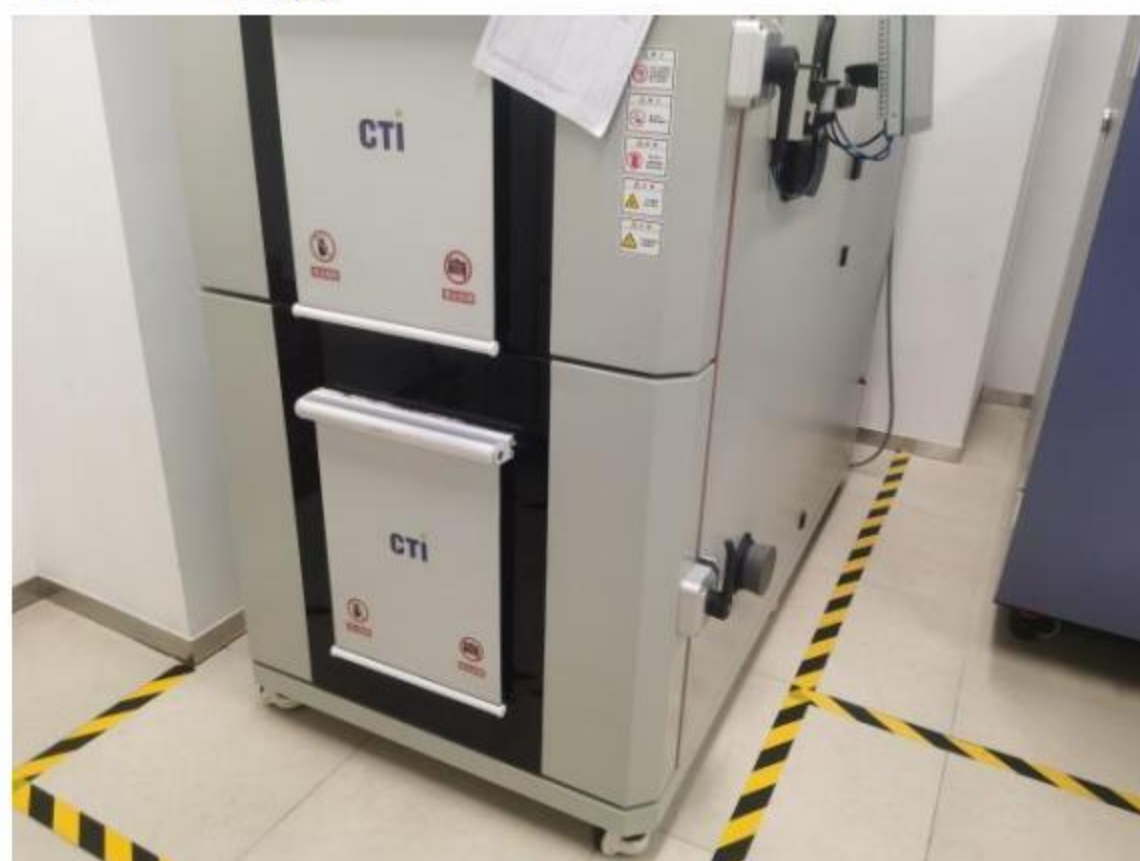
Testing 65°C

Test temperature: (65±2) °C, 2h→(-20±2) °C, 2h, 30s to complete the exchange;

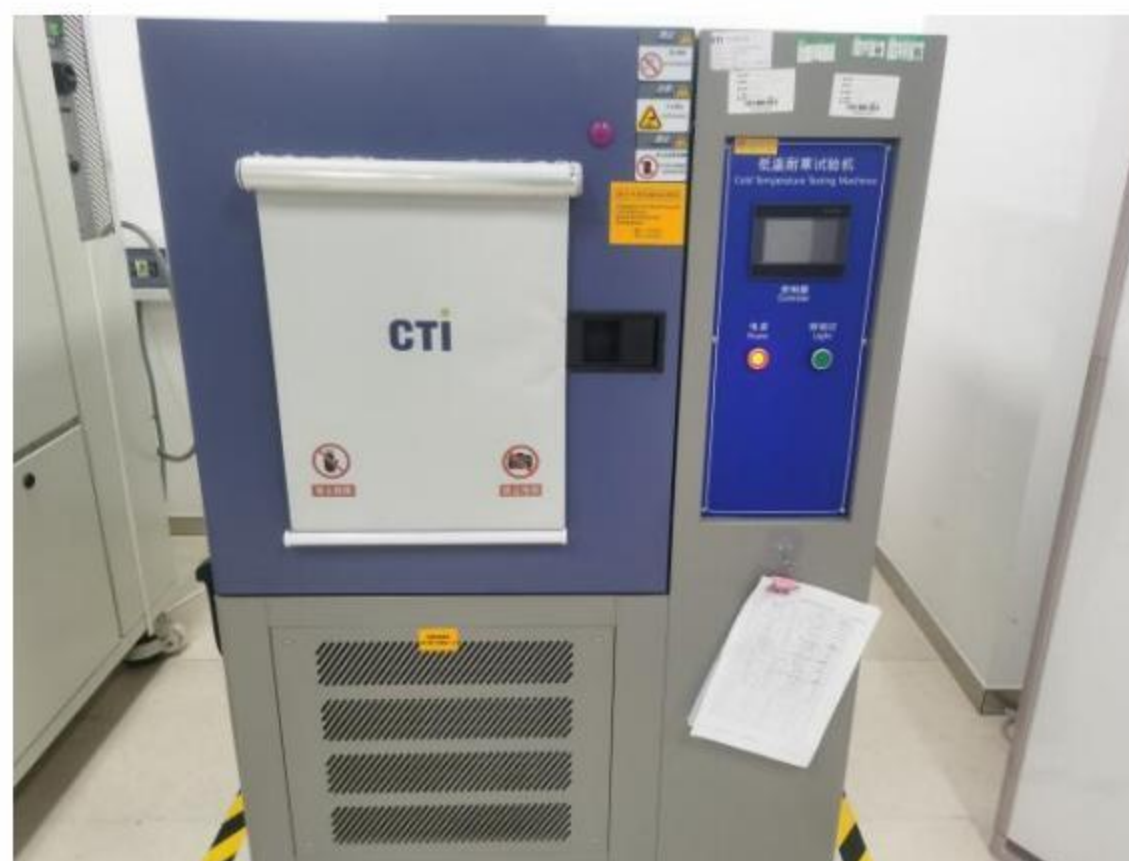
Testing -20°C

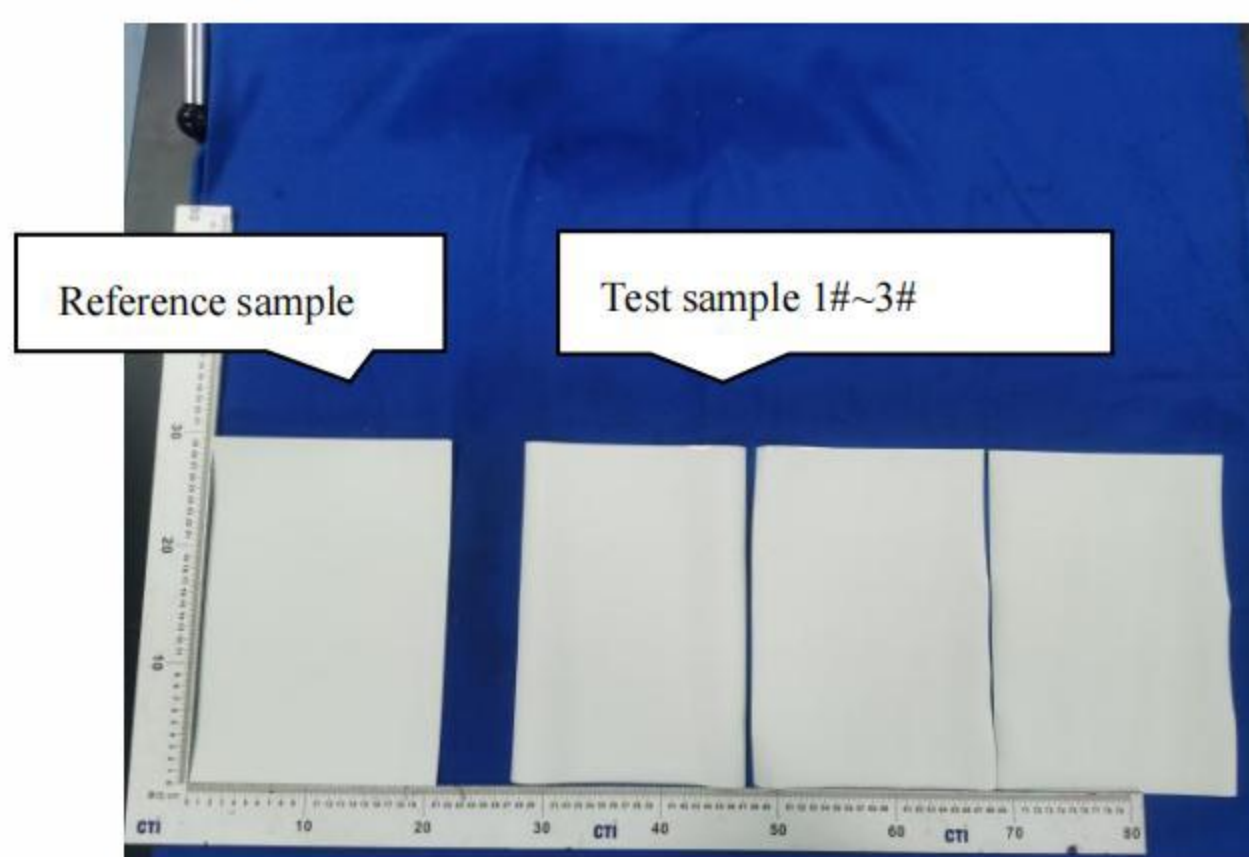
After the test

| Sample No. | | Appearance(Visual observation) | Test Requirements | Conclusion |
|---|---|---|---|---|
| A2240538404101001 | 1# | Wrinkling can be seen, no discoloration, no loss of light, no blistering, no cracking | Wrinkling can be seen, no discoloration, no loss of light, no blistering, no cracking | Pass |
| | 2# | Wrinkling can be seen, no discoloration, no loss of light, no blistering, no cracking | | Pass |
| | 3# | Wrinkling can be seen, no discoloration, no loss of light, no blistering, no cracking | | Pass |

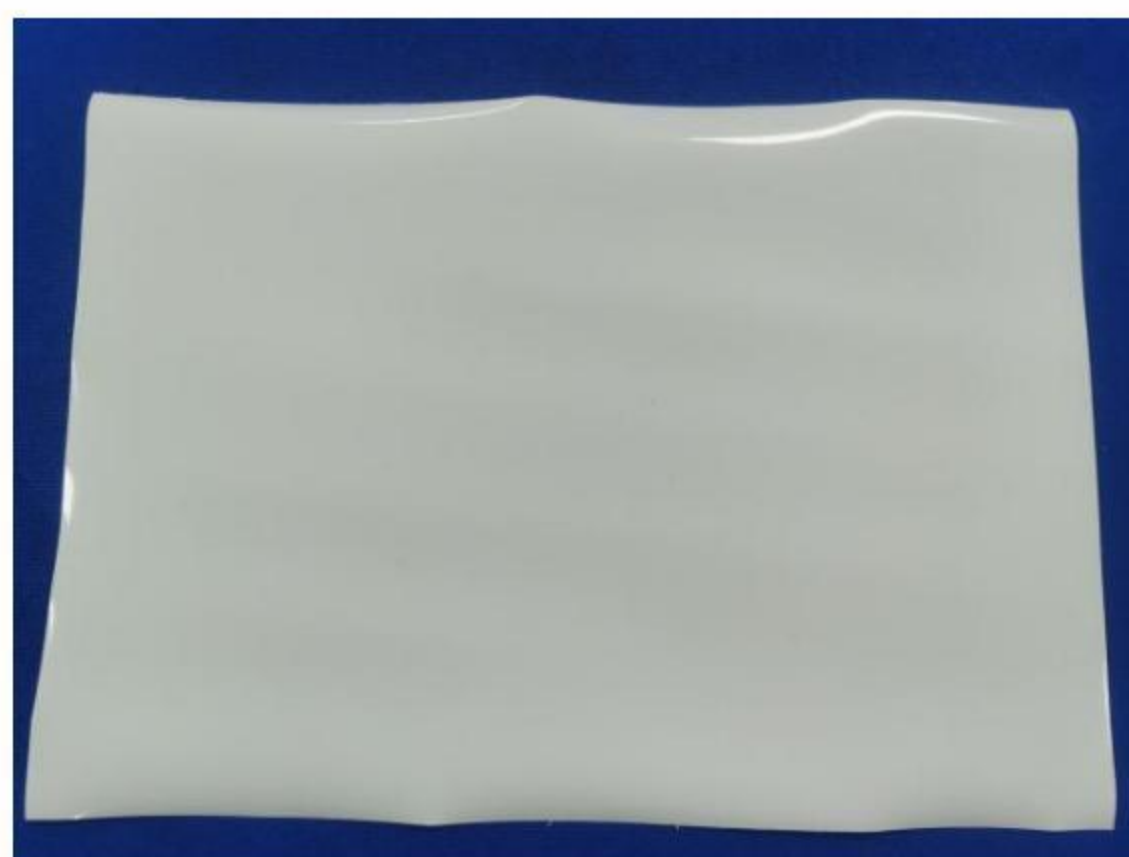
Detail
